# 9: ROOF

## Information

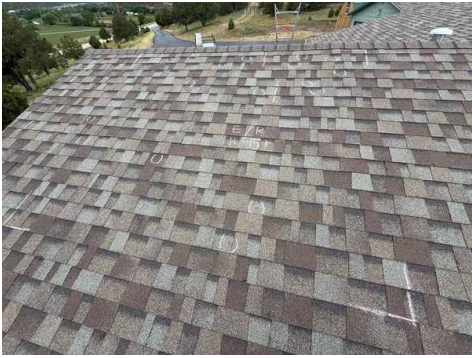
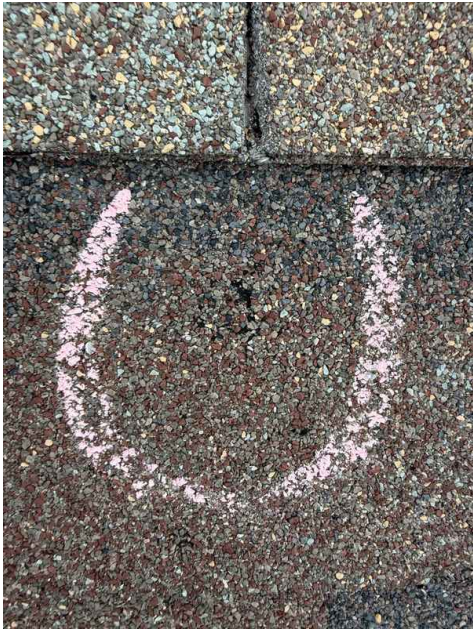
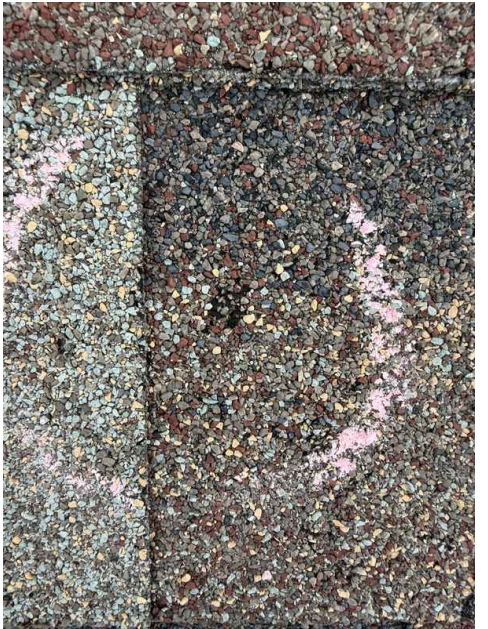
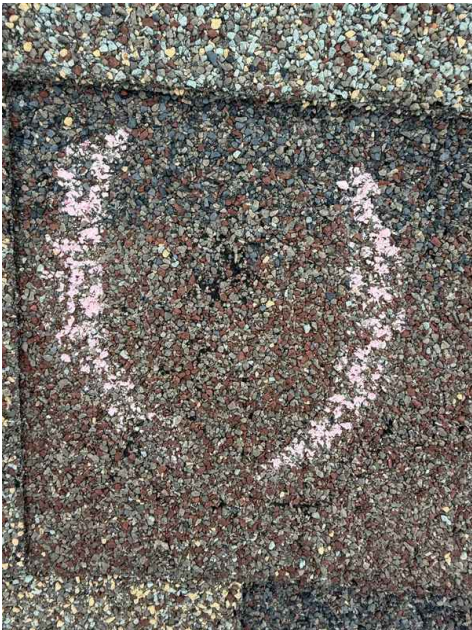
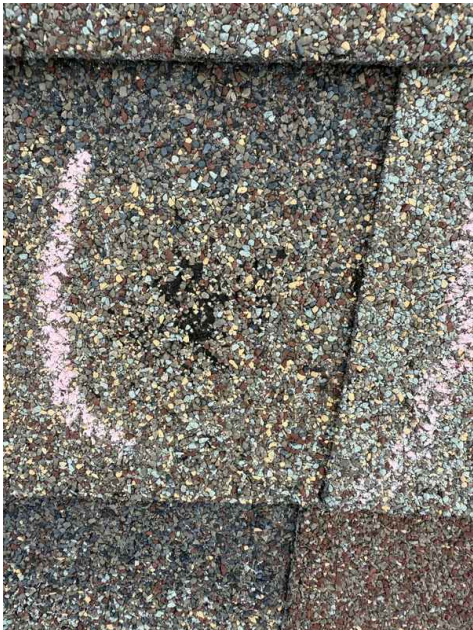
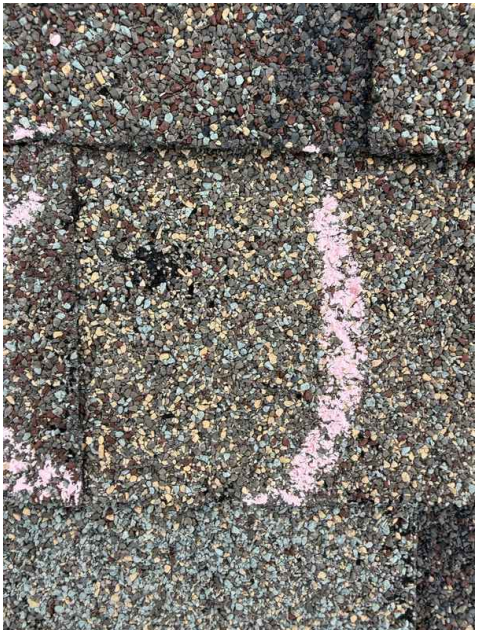
9.2.1 Right Slope

**HAIL DAMAGE**

There appeared to be hail damage during the time of inspection.

Haag Engineering defines hail damage as: Physical damage caused by hailstone impact that results in the loss of granules, bruising, fracturing, or puncturing of the shingle mat, which may affect the shingle’s ability to shed water or reduce its expected service life.

Contact a qualified gutter contractor

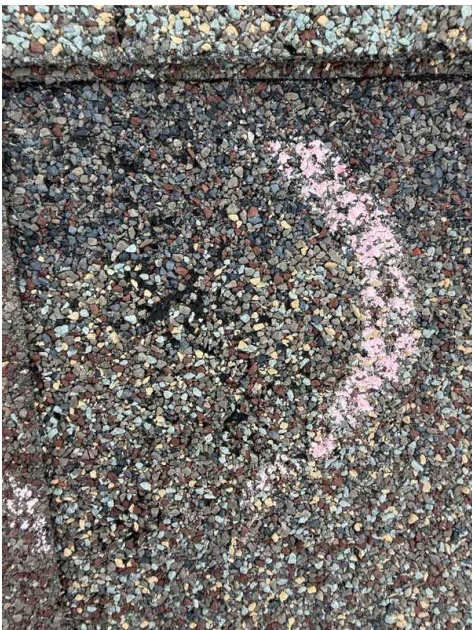
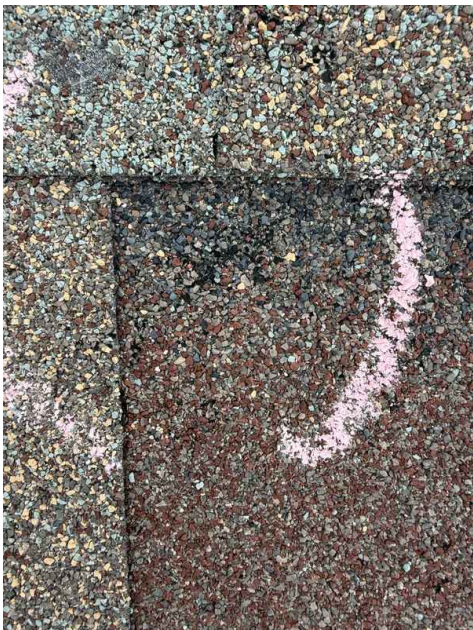
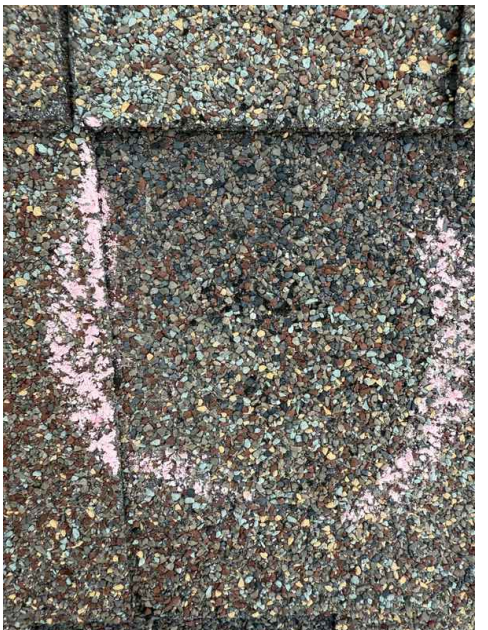
Hail damage is the result of hailstones impacting a surface, causing varying degrees of harm, including dents, cracks, bruises or fractures, typically observed on roofing materials, siding, windows, and gutters, etc.

Recommendation

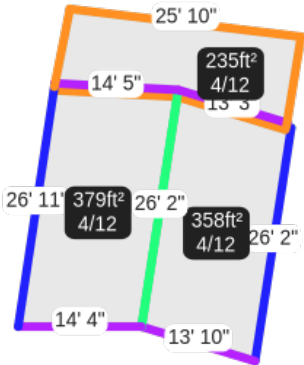
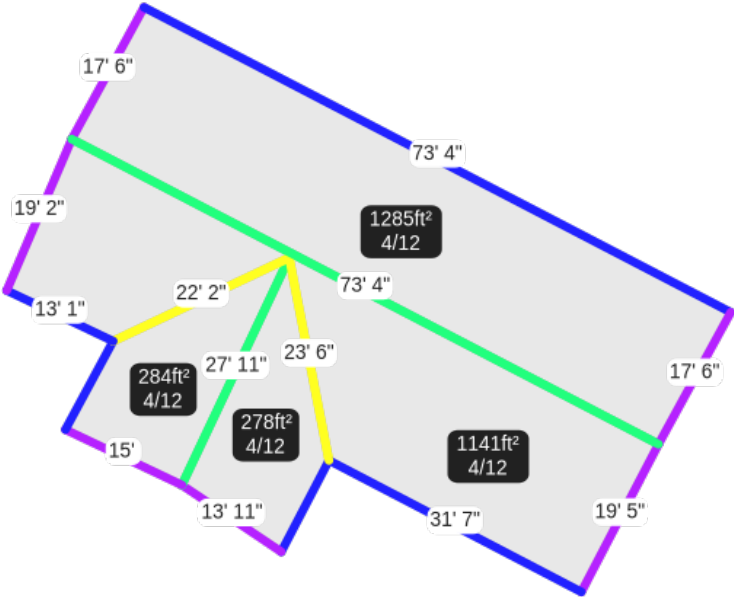
| Line Type | | Total Length (ln.ft) | Line Type | | Total Length (ln.ft) |
| Ridge | ● | 127.42 | Rake | ● | 158.33 |
| Hip | ● | 0.00 | Eave | ● | 193.67 |
| Valley | ● | 45.67 | Apron Flashing | ● | 71.00 |
| Penetration | | 0 | Step Flashing | ● | 0.00 |

| Pitch | Area (SQ) | % of Roof |
| 4/12 | 39.62 | 100.00 |

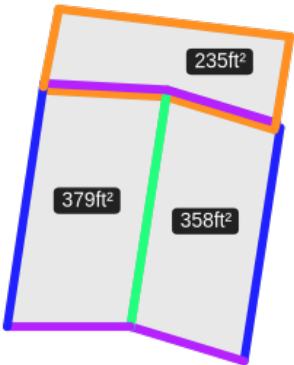
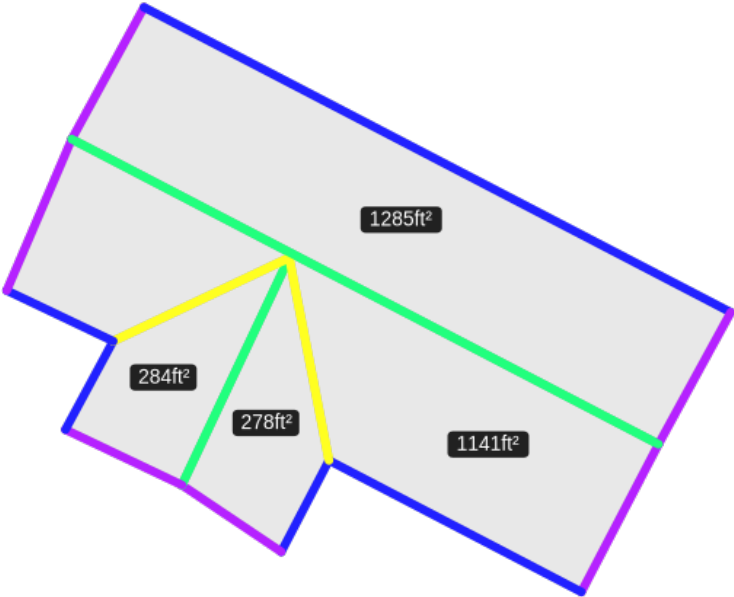
| Line Type | | Total Length (ln.ft) | Line Type | Total Length (ln.ft) |
| Ridge | ● | 127.42 | Rake | 158.33 |
| Hip | ● | 0.00 | Eave | 193.67 |
| Valley | ● | 45.67 | Apron Flashing | 71.00 |
| Penetration | | 0 | Step Flashing | 0.00 |

| Pitch | Area (SQ) | % of Roof |
| 4/12 | 39.62 | 100.00 |

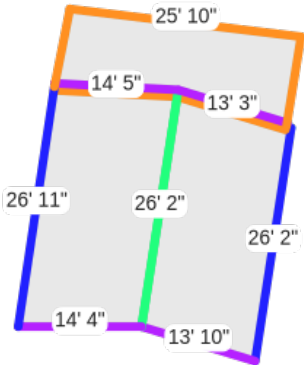
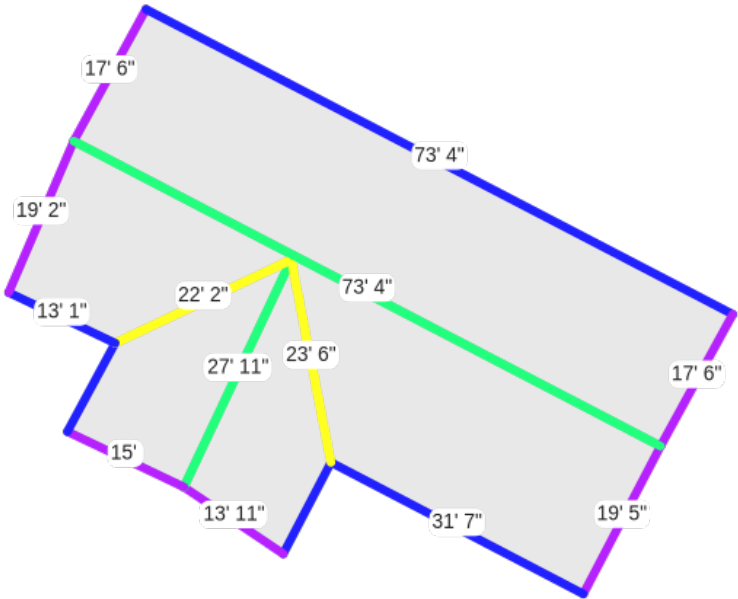
| Line Type | | Total Length (ln.ft) | Line Type | | Total Length (ln.ft) |
| Ridge | ● | 127.42 | Rake | ● | 158.33 |
| Hip | ● | 0.00 | Eave | ● | 193.67 |
| Valley | ● | 45.67 | Apron Flashing | ● | 71.00 |
| Penetration | | 0 | Step Flashing | ● | 0.00 |

| Pitch | Area (SQ) | % of Roof |
| 4/12 | 39.62 | 100.00 |

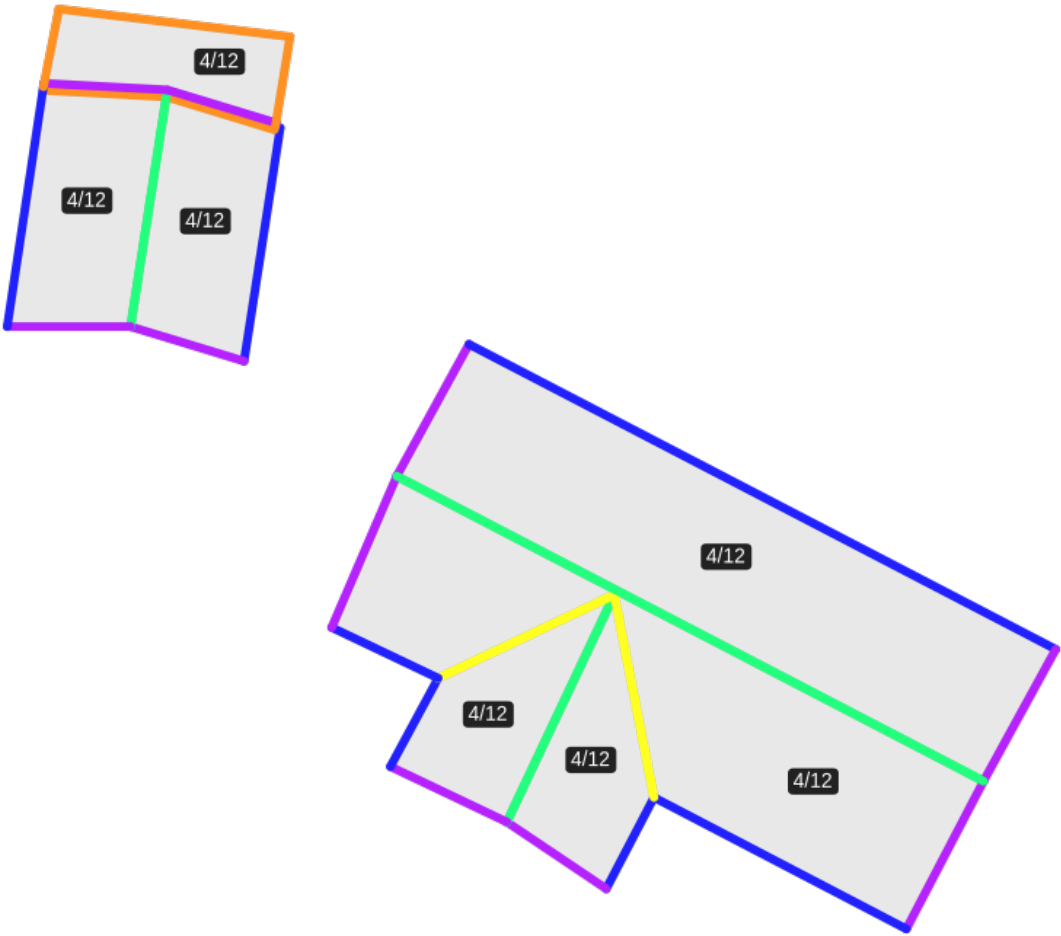
| Line Type | | Total Length (ln.ft) | Line Type | | Total Length (ln.ft) |
| Ridge | ● | 127.42 | Rake | ● | 158.33 |
